Southern Ocean Exploration Maritime Archaeology Report

Subject: Aircraft wreckage located off Stanley Tasmania

Report Date: 14-11-2023

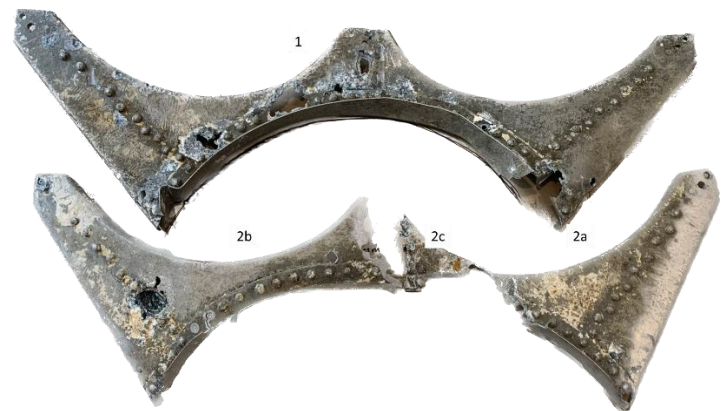
The recovered material consisted of two identical alloy brackets of which one was broken into three pieces – Fig 1. 2a, 2b & 2c. The three pieces of bracket 2 aligned at the break point and it appears that bracket 2 was originally intact and subsequently damaged during to process of being caught in the scallop dredge. The brackets appeared damaged and distorted from other actions prior to being retrieved from the sea floor.

Fig. 1. – Brackets 1 & 2 front view.

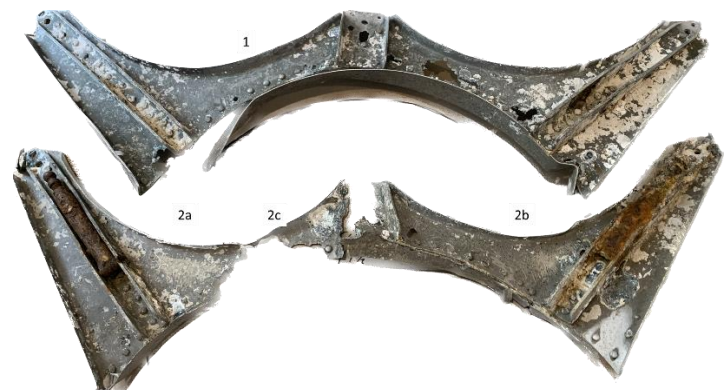
Fig. 2. Brackets 1 & 2 rear view.

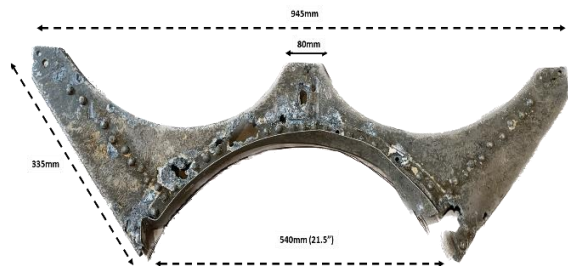
The curved section of the bracket is 540mm (21.5") diameter with the total bracket width 945mm.

Fig. 3. Bracket 1 dimensions.

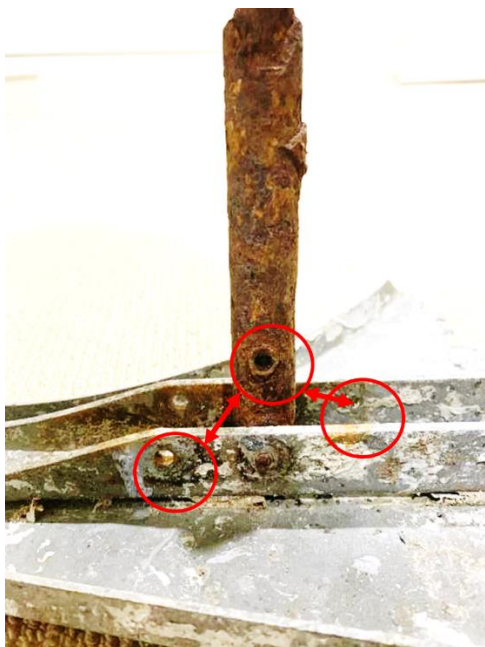
Bracket 2 had two steel rods inserted along the channelled section that would pivot 180° at the base. There is a locking pin position on both sides of the pivot point whereby the rod could be locked in two positions 180° opposing. The steel rod on part 2c was locked in the upright position with the pin still in situ. The rod on part 2a had no pin present and could rotate freely. Bracket 1 rods were absent.

Fig. 4. Bracket 2a rod locking pin position.

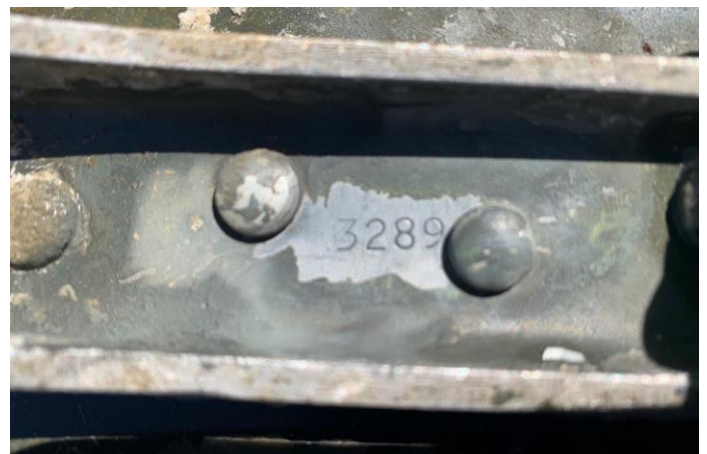
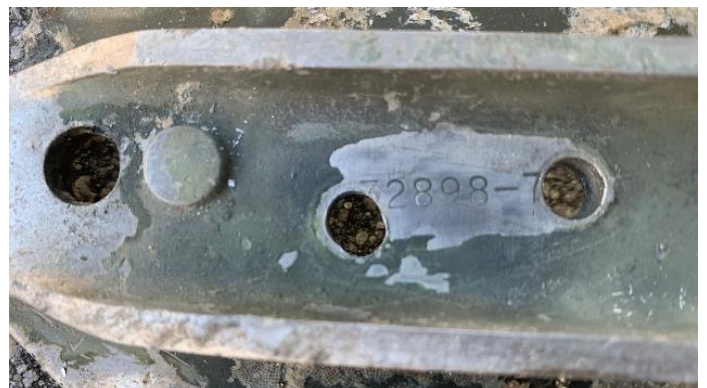
The question then remained as to what aircraft these artefacts belonged to and how did they end up on the sea floor. The key to this identification was to locate a part number on either of the brackets. Jason Stagg identified where the part number was likely to be located. Martin Tozer carefully removed the marine growth and paint to locate any numbers. Two partial numbers were found on bracket 1 channelled sections. However, the full number was obscured by rivets installed over the numbers.

From combining the two partial numbers a part number was determined as being 32898-7.

Fig. 5. Part numbers from either side of Bracket 1 channelled sections.

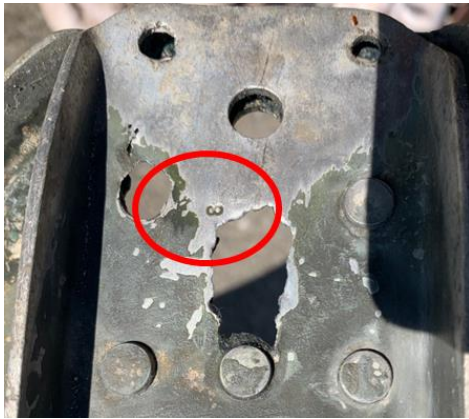
Additionally the number 8 was identified stamped on the middle gusset (Fig. 6).

Fig. 6. Middle gusset part number "8".

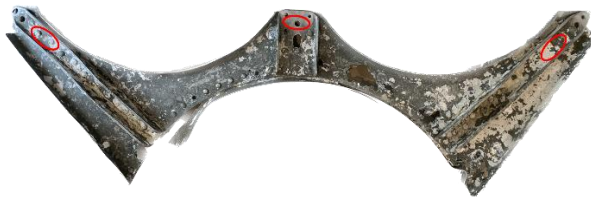
Fig. 7. Bracket part number locations on each channel and the middle gusset.

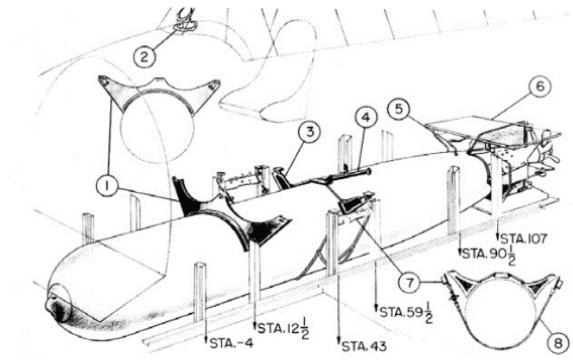
| 1 Front Sway Brace | 5 Lanyard |
| 2 Mk. 8 Gun Sight | 6 Torpedo Stabilizer |
| 3 Rear Sway Brace | 7 Shackie |
| 4 Brace Assembly | 8 Sling |

Fig. 9. Avenger Torpedo Rack Assembly – note item 1 Front Sway Brace. (Jason Skagg).

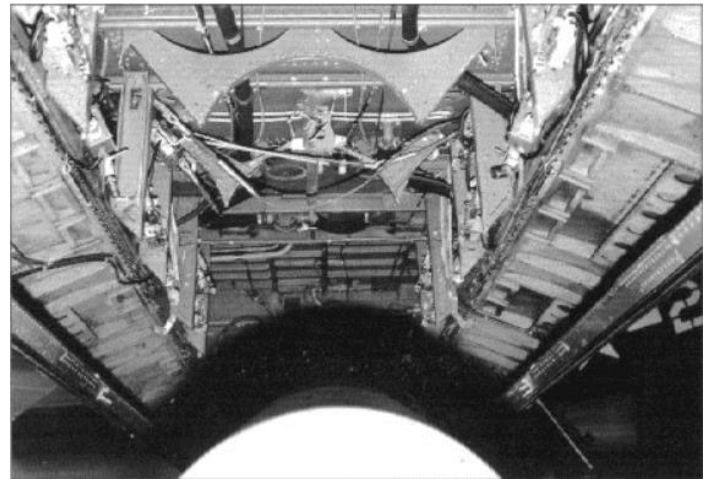
Fig. 10. Avenger Torpedo Rack Bomb Bay with Front and rear Sway Brace. (Jason Skagg)

The fishermen who inadvertently retrieved the artefacts, detailed how there were two fishing boats each trawling a single scallop dredge side by side. Each dredge had collected a single brace. There was no other wreckage recovered. As the Sway Brace is located well inside the Avenger bomb bay (Fig. 10), it would be improbable to trawl up the Sway Brace only without damaging and collecting other aircraft wreckage. As the two recovered brackets are identified as the Front Sway Brace, they can only have come from two different aircraft. To recover the exact same item from two different aircraft at the same time is even more improbable.
